CASE STUDY

# Hartwick College

## LED EXTERIOR LIGHTING

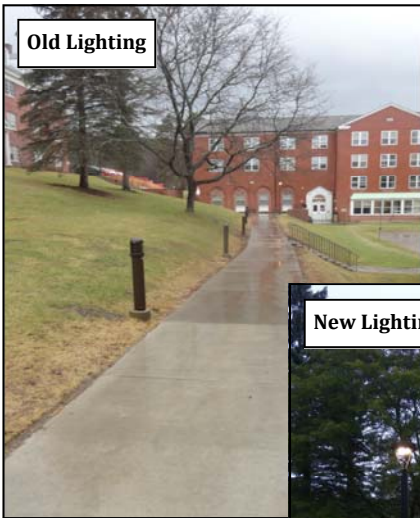
Old Lighting

Ongoing LED exterior lighting upgrades for Hartwick's 10-15 Year old campus exterior lighting system. Upgrades driven by maintenance issues, high energy costs, campus revitalization and requested improved evening/night visibility for safety and student foot travel.

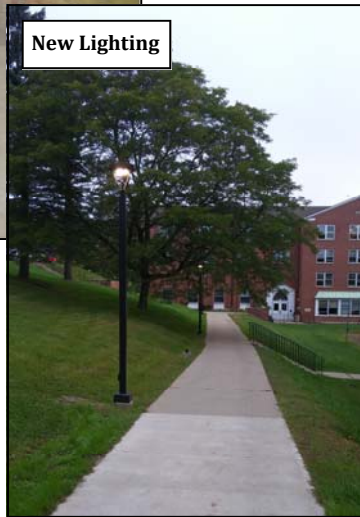
New Lighting

Many exterior LED lighting updates and renovations. This phase of updates included replacing walkway lined metal halide bollard lighting with decorative post top LED pole lights. The light fixture quantity was reduced by 50% and the existing bollard bases were reconditioned and used to reduce project labor and material costs. Also included in this phase were new light pole installations, area light replacements and new LED wall packs. 70% energy savings with vastly improved nighttime light levels, light quality and visual appeal.
